# Renovational Improvement of Optical Performance of Kottamia 188cm Telescope in Egypt

**Toshiyuki Sasaki, Takeshi Noguchi, Hisashi Koyanao, Kazuhiro Sekiguchi (NAOJ), Gamal B. Ali, Hamed Ismail, Ahmed Essam, Aly Haroon, Ibrahim Selim (NRIAG)**

## 1. Kottamia 188cm Telescope

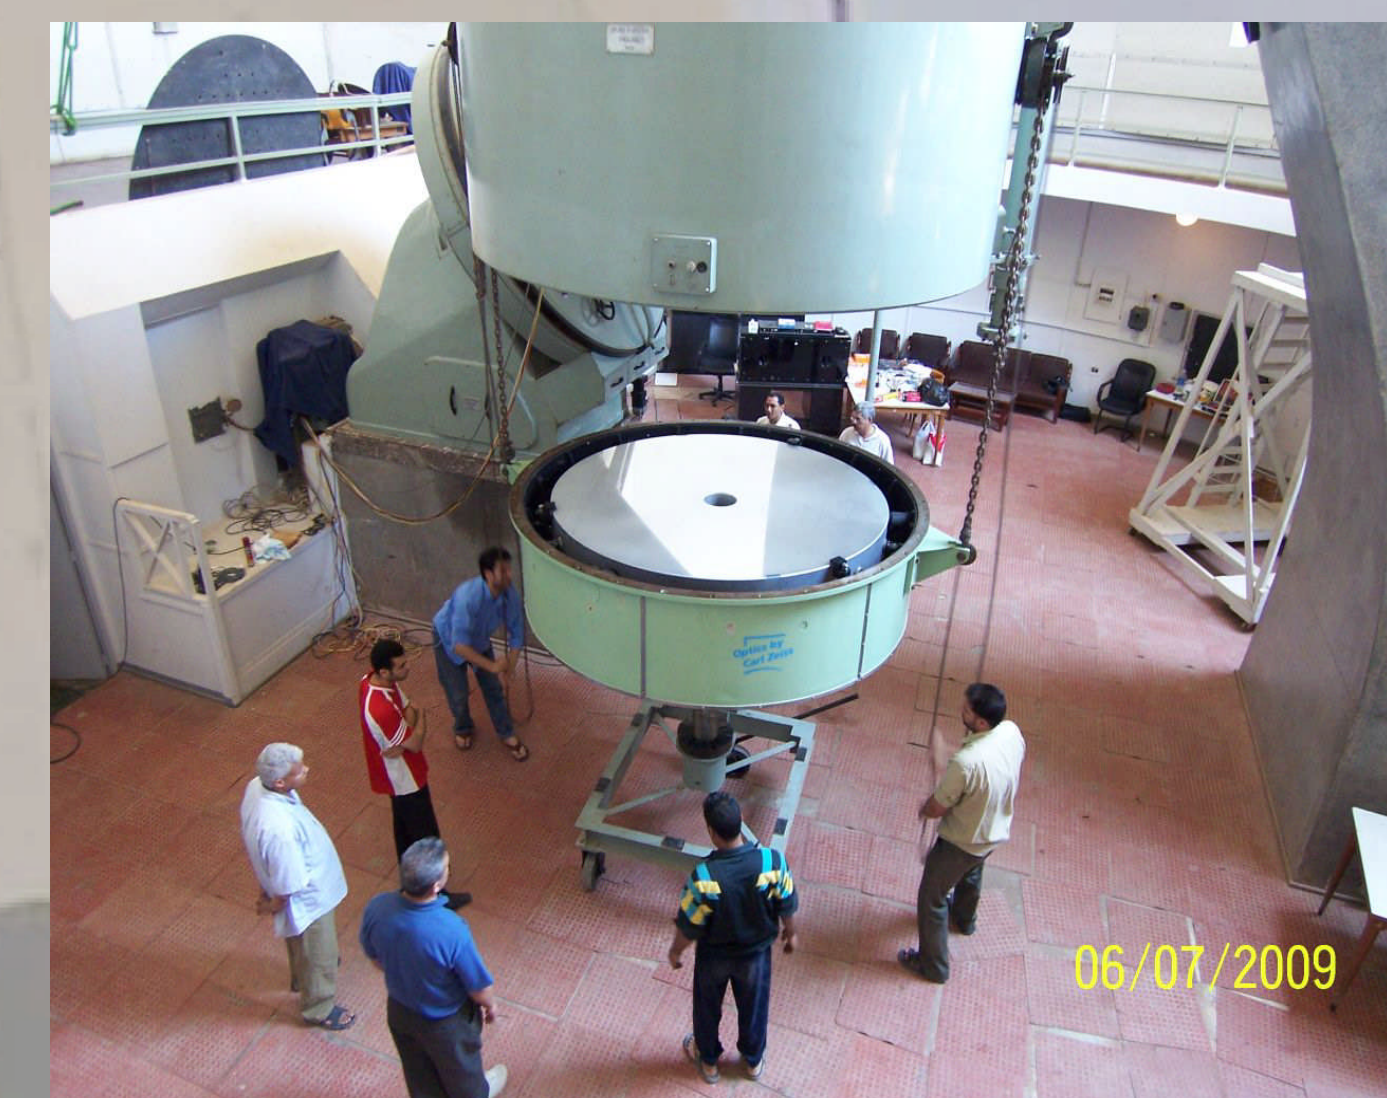
Removal of the mirror cell

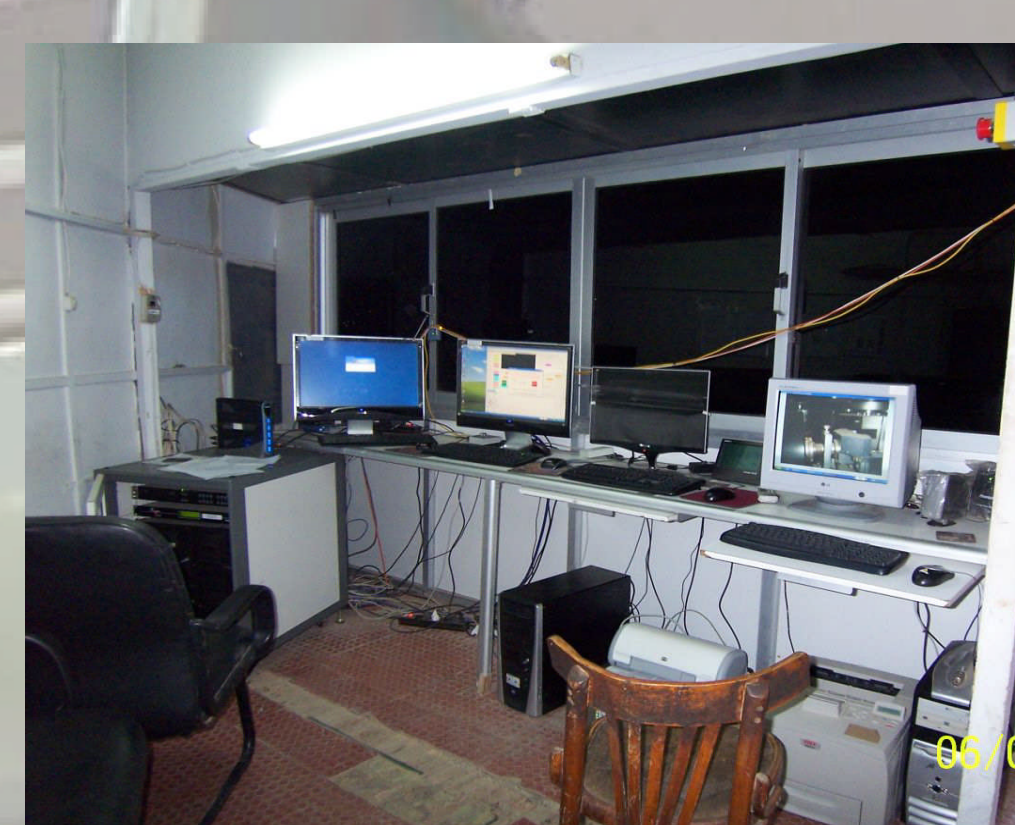
**Computerized Telescope Control System**

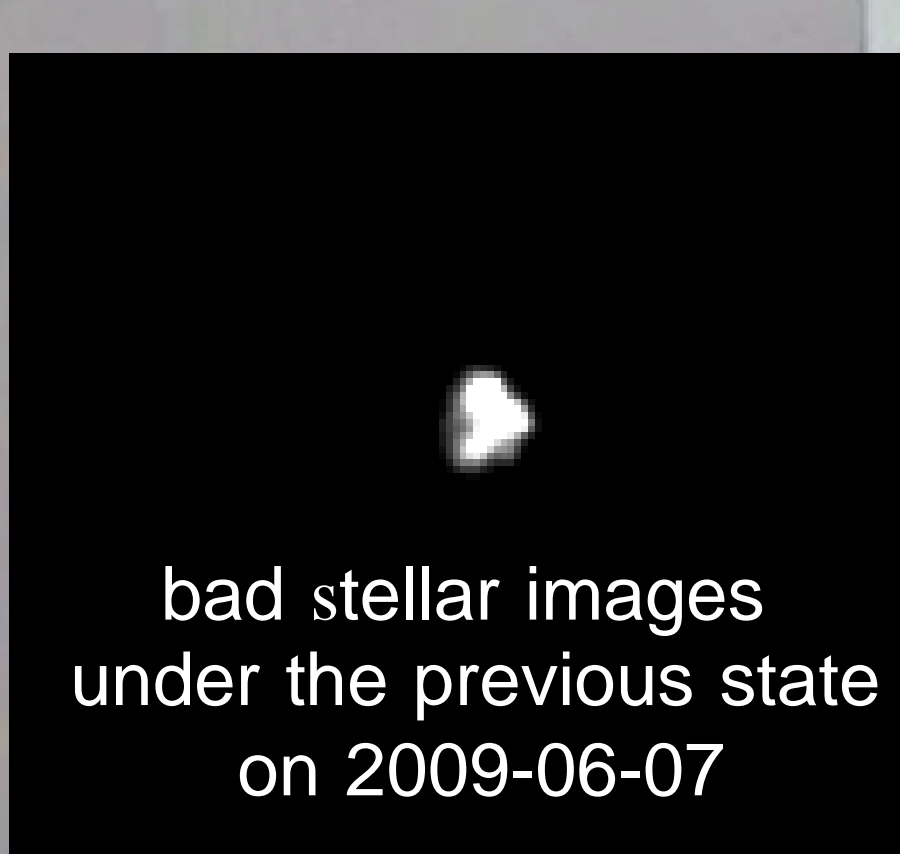
Mirrors, M1 and M2, with its mirror cell were remade by Carl-Zeiss in 1995 with its initial image quality of 0.25 arcsec in diameter. After settling them to the telescope, stellar images have been splitted into three segments nearly over 10 years!

bad stellar images under the previous state on 2009-06-07

**2.2** checked and adjusted **unbalanced heights of axial support system**, which causes the bad 3-segmented stellar images. it's **Fixed**.
